Evaluation of Potential Use of Vegetation for Erosion Abatement Along the Great Lakes Shoreline

by
V.L. Hall and J.D. Ludwig

MISCELLANEOUS PAPER NO. 7-75
JUNE 1975

Prepared for
U.S. ARMY, CORPS OF ENGINEERS
COASTAL ENGINEERING
RESEARCH CENTER

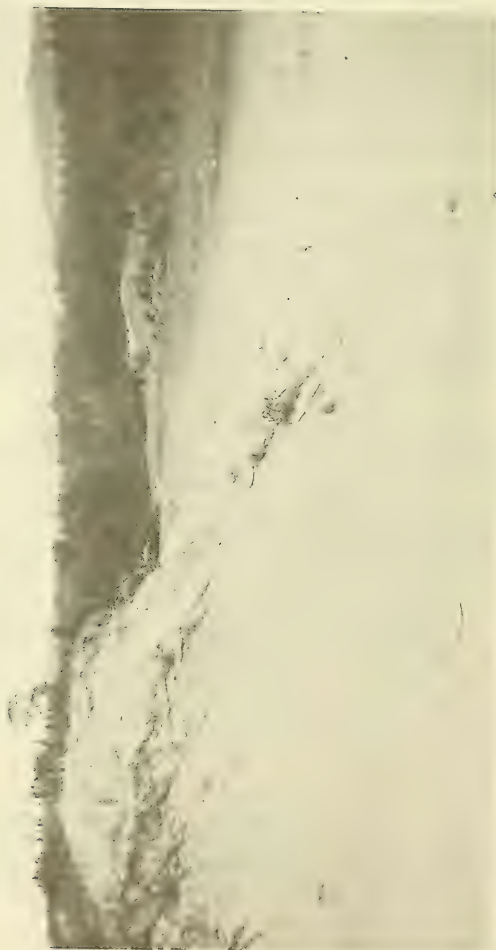
Figure 2. Sand blowout caused by wind erosion.

Sand dunes of the Grand Sable Banks near Grand Marais, Michigan, are subject to blowouts (Fig. 2) and wind erosion. The shore at Whitefish Point, Michigan, is relatively flat and is eroding. Rock was exposed in many areas, but where vegetation existed, it retained small mounds of sand; this area showed some of the most successful examples of sand retention by vegetation.

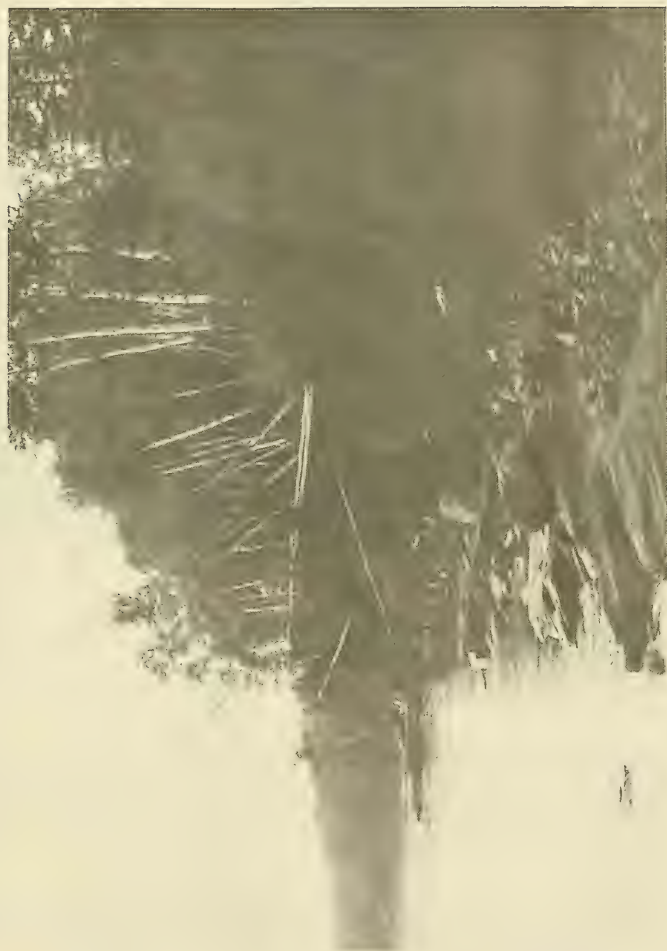
Figure 5. Wave scouring causes undercutting and bank recession with loss of vegetation.

Some bank erosion along the Lake Superior shore was caused by seepage (Fig. 4) and wave scouring (Fig. 5). Only one structure was noted, riprap to abate bank erosion near the State highway at Herbster, Wisconsin. The treatment appeared successful; the bank was stabilized, with vegetation well established between the riprap and road to prevent erosion due to surface runoff.

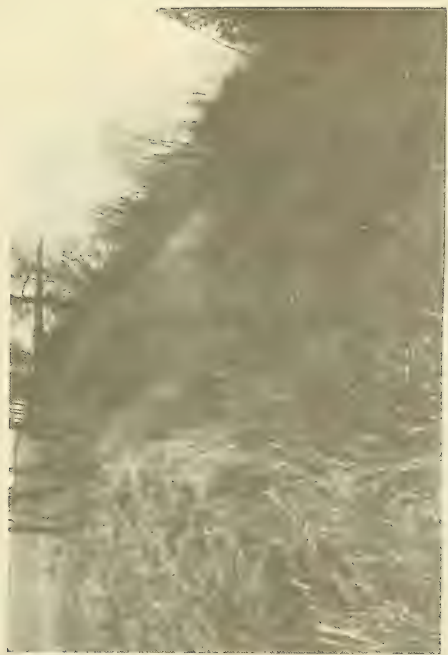
Figure 6. Lake Michigan bank erosion caused by seepage through sand and gravel layers in the glacial till (left). Dewatering, bank reshaping, and seeding to prevent erosion by runoff has stabilized bank recession (above). (Courtesy of Soil Conservation Service.)

The Soil Conservation Service at Kewaunee, Wisconsin, has successfully stabilized shores by dewatering the glacial till, sloping the face of the bluffs, and seeding the reshaped slopes (Fig. 6). In this case, dewatering is the key factor and is essential to control erosion caused by seepage.

Land alteration has proved essential for controlling shore and bank erosion in many areas of the Great Lakes. Near Kewaunee, Wisconsin, for example, seepage contributes to bank failure along Lake Michigan. The Soil Conservation Service has successfully installed a deep tile line to intercept seepage and conduct the underground water to Lake Michigan. The banks were reshaped to an approximate slope of 2:1 and the soil was seeded with a mixture of crown vetch and fescue to control surface runoff. Similar dewatering has been effective in urban and rural areas. The work is costly, especially on high banks. In time, if seeding has successfully stabilized soil on the banks, native plant species invade and become established along with planted species.

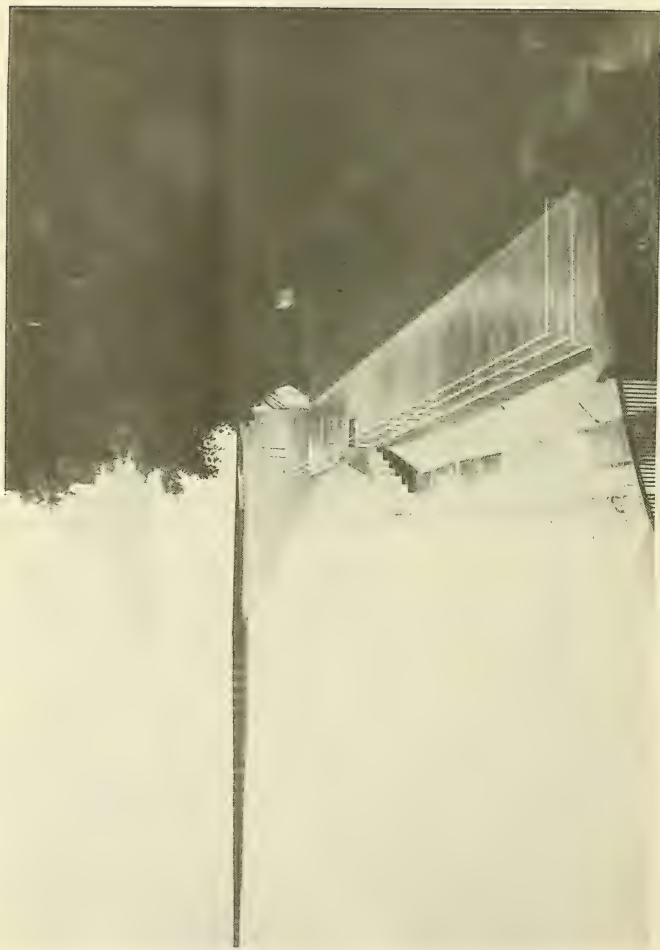
Figure 7. A seawall at Kenilworth, Illinois, has successfully stabilized the bank.

At the Kenilworth, Illinois, Public Water Works, a concrete seawall and groin have been built (Fig. 7). A private residential beach fronted the seawall, but the recent rise in water level has reduced the beach to a small area adjacent to the groin. This seawall has successfully controlled bank erosion.

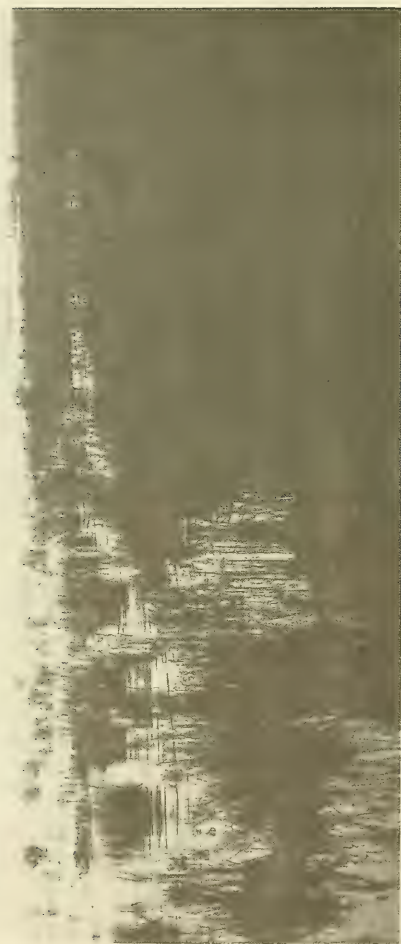
Figure Gently sloping shoreline (Lake Michigan) and relatively quiet waters provide a suitable habitat for bluejoint, great bulrush, and rush.

A gently sloping shore 3.5 miles east of State Route 134 and the Interstate 75 interchange provided suitable habitat for bluejoint, great bulrush, and rush (Fig. 8). Although bluejoint and rush are flood-tolerant, they are not important species for wave attenuation.

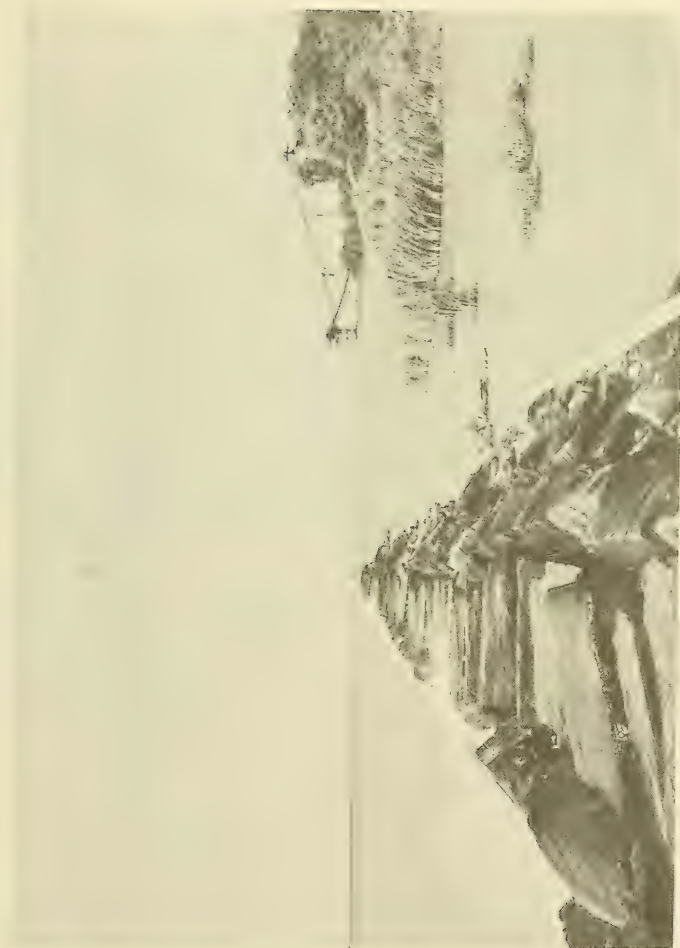
Figure 9. Protective structure creating pool favorable for growth of reed.

A breakwater jetty at Ashtabula, Ohio, produced a stilling effect between the structure and the shore, providing habitat for reed (Fig. 9).

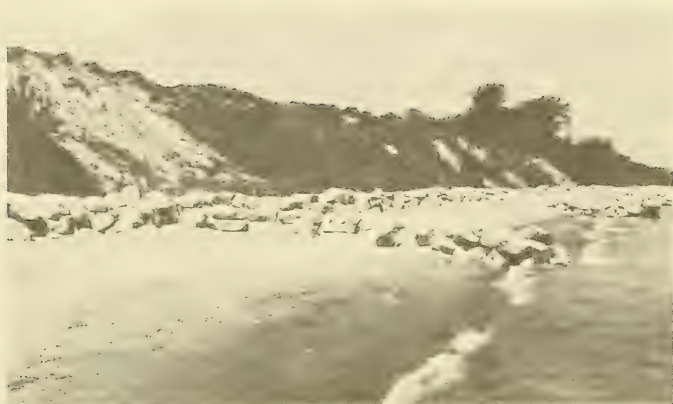
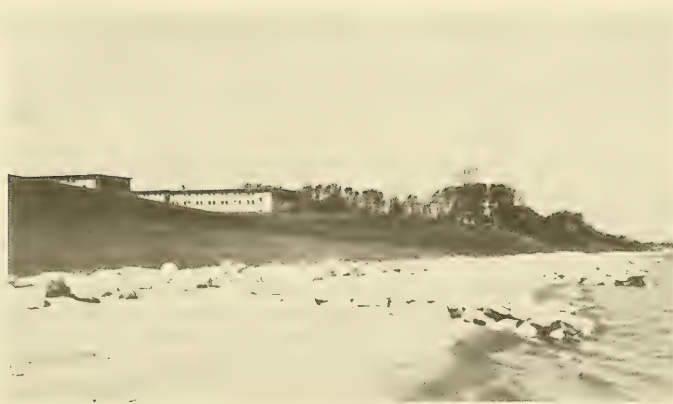
Figure 11. Reformation of rough bank (above) and landscaping of shoreline (below).
(Courtesy of Soil Conservation Service.)

An example of a Lake Michigan shore modification is shown in Figure 11. The site was in Racine County about 3 miles north of Racine, Wisconsin. Rock was used for shoreline protection to minimize erosion of the embankment. The rough steep bank was graded to a more gentle slope and was seeded to control surface erosion. This shore front modification requires a soil that is not subject to seepage so severe that it causes bank failure. Loam soil is best for this type of reclamation. The best vegetative growth is obtained by topdressing with fertilizer and irrigating. Where a specific type of vegetation is desired, weed control may also be required. This shore front renovation requires constant management to maintain a turf appearance.
